TECHNICAL REPORT GL-87-14

SEISMIC STABILITY EVALUATION OF FOLSOM DAM AND RESERVOIR PROJECT

Report 3 CONCRETE GRAVITY DAM

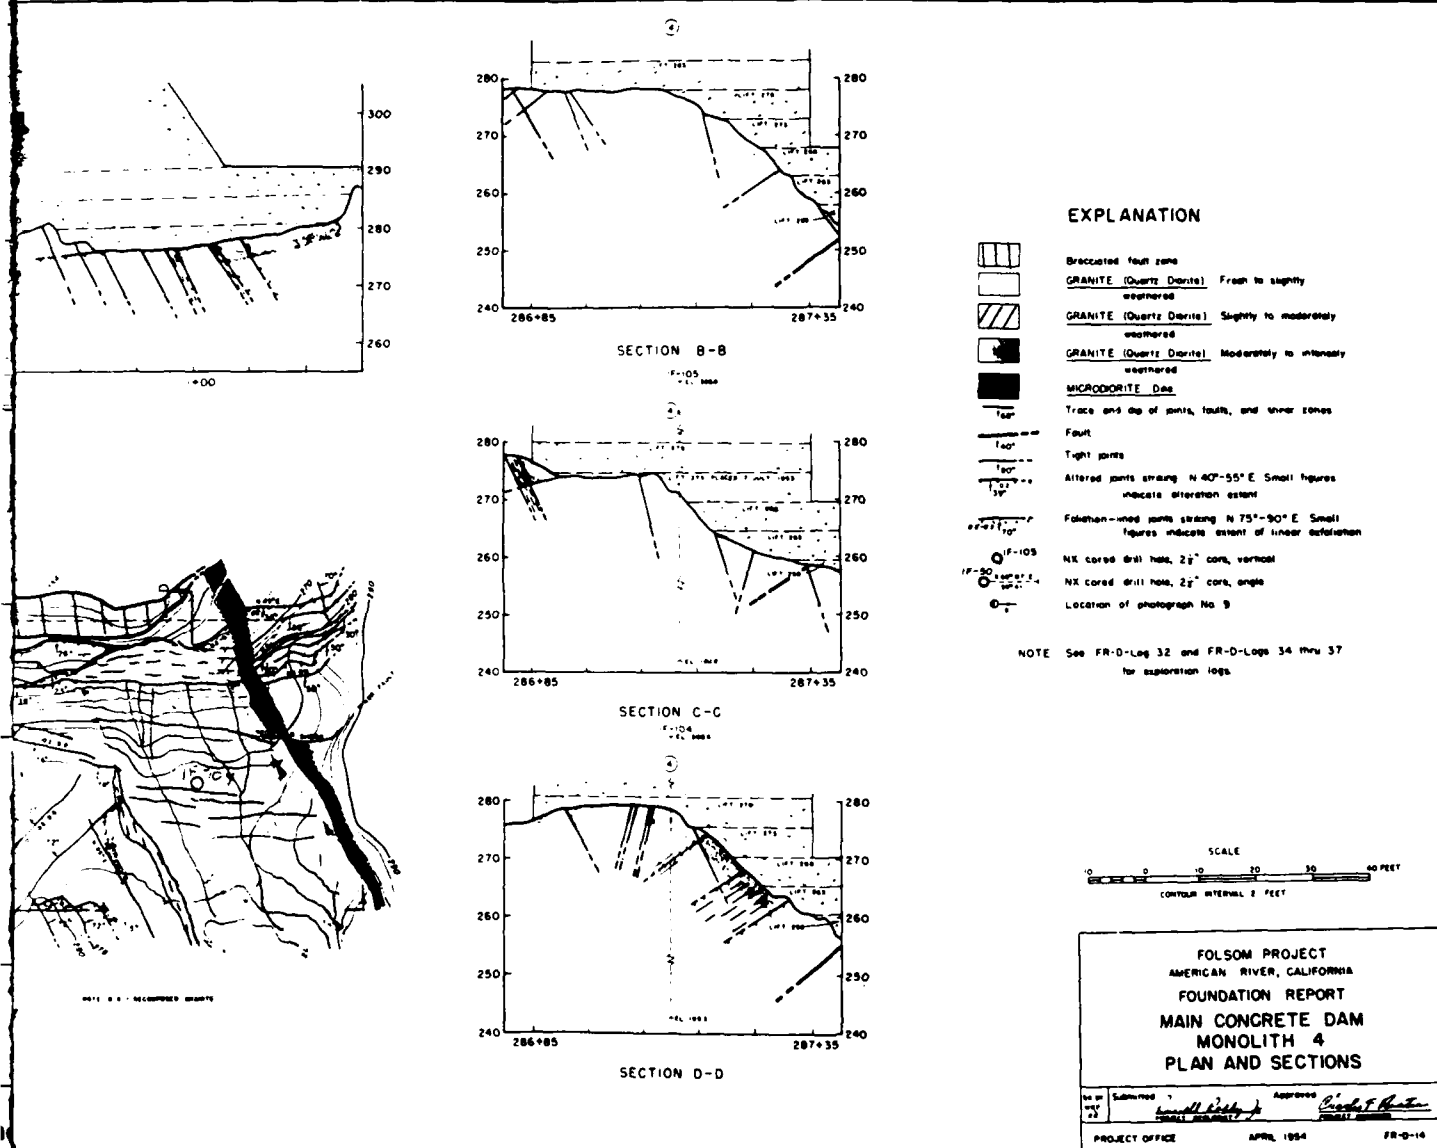
Figure 6. Plan and Sections of Concrete Gravity Dam Moi

and Sections of Concrete Gravity Dam Monolith 4.

- Cross-section (SECTION A-A):** A vertical slice of the dam showing its internal structure. The vertical axis represents elevation from 240 to 300 feet. The horizontal axis represents distance from 10+00 to 11+00. The section shows a concrete dam with a spillway on the right, a reservoir on the left, and various layers of reinforcement and foundation material. Labels include "SECTION A-A", "10+00", "10+50", "11+00", and "287+35".

- Plan View (PLAN):** A top-down view of the dam and its surroundings. It shows the dam's footprint, the reservoir, the spillway, and the foundation. The plan view includes a north arrow, a scale bar, and various labels for different parts of the dam and its surroundings. The plan view is labeled "PLAN" and "287+35".

The drawing is a technical drawing of a dam project, showing the dam's structure, foundation, and surrounding terrain. It includes a cross-section, a plan view, and three vertical profile views. The drawing is labeled "SECTION A-A", "PLAN", and "287+35".

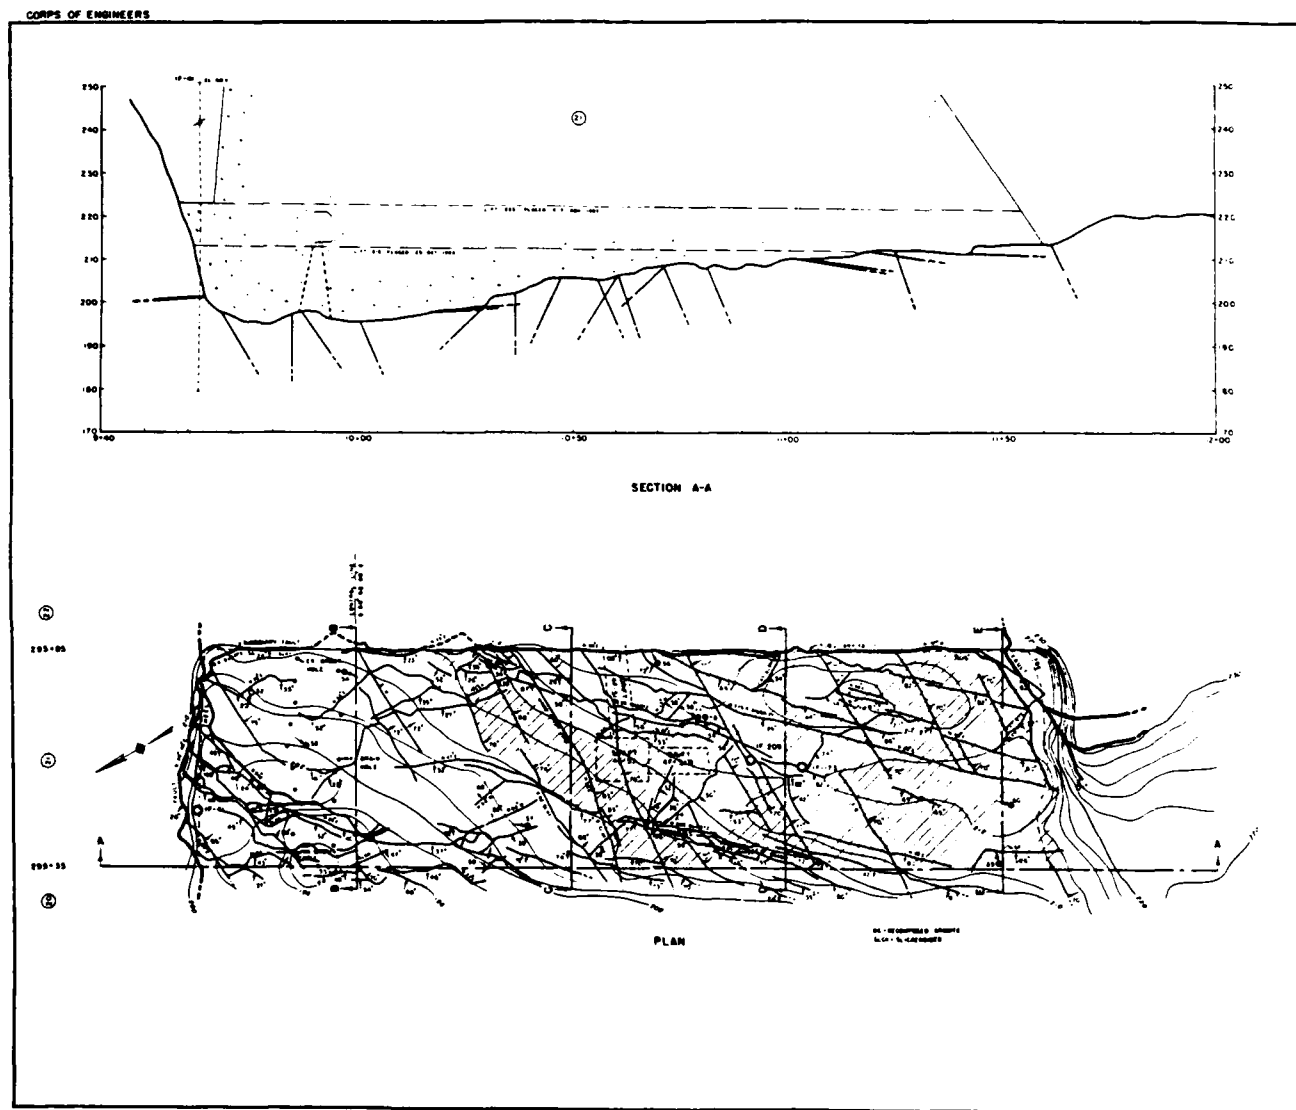
Figure 22. Plan and Sections of Concrete Gravity Dam M

Plan and Sections of Concrete Gravity Dam Monolith 20.

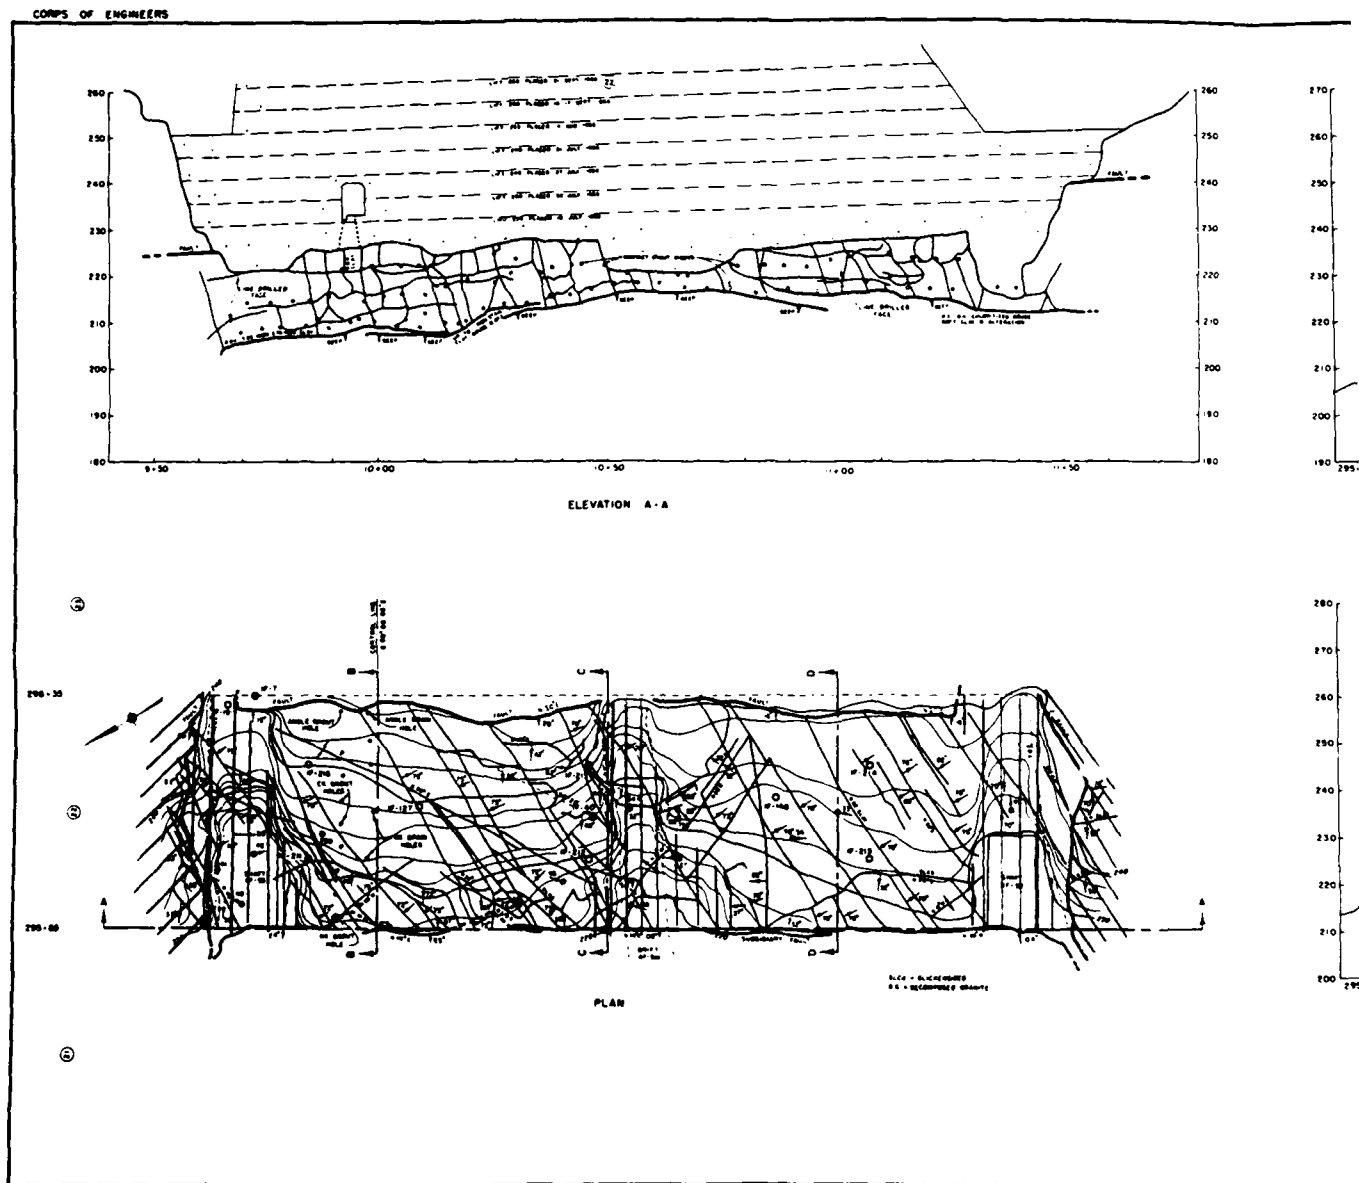
Figure 23. Plan and Sections of Concrete Gravity Dam Monolith

and Sections of Concrete Gravity Dam Monolith 21.

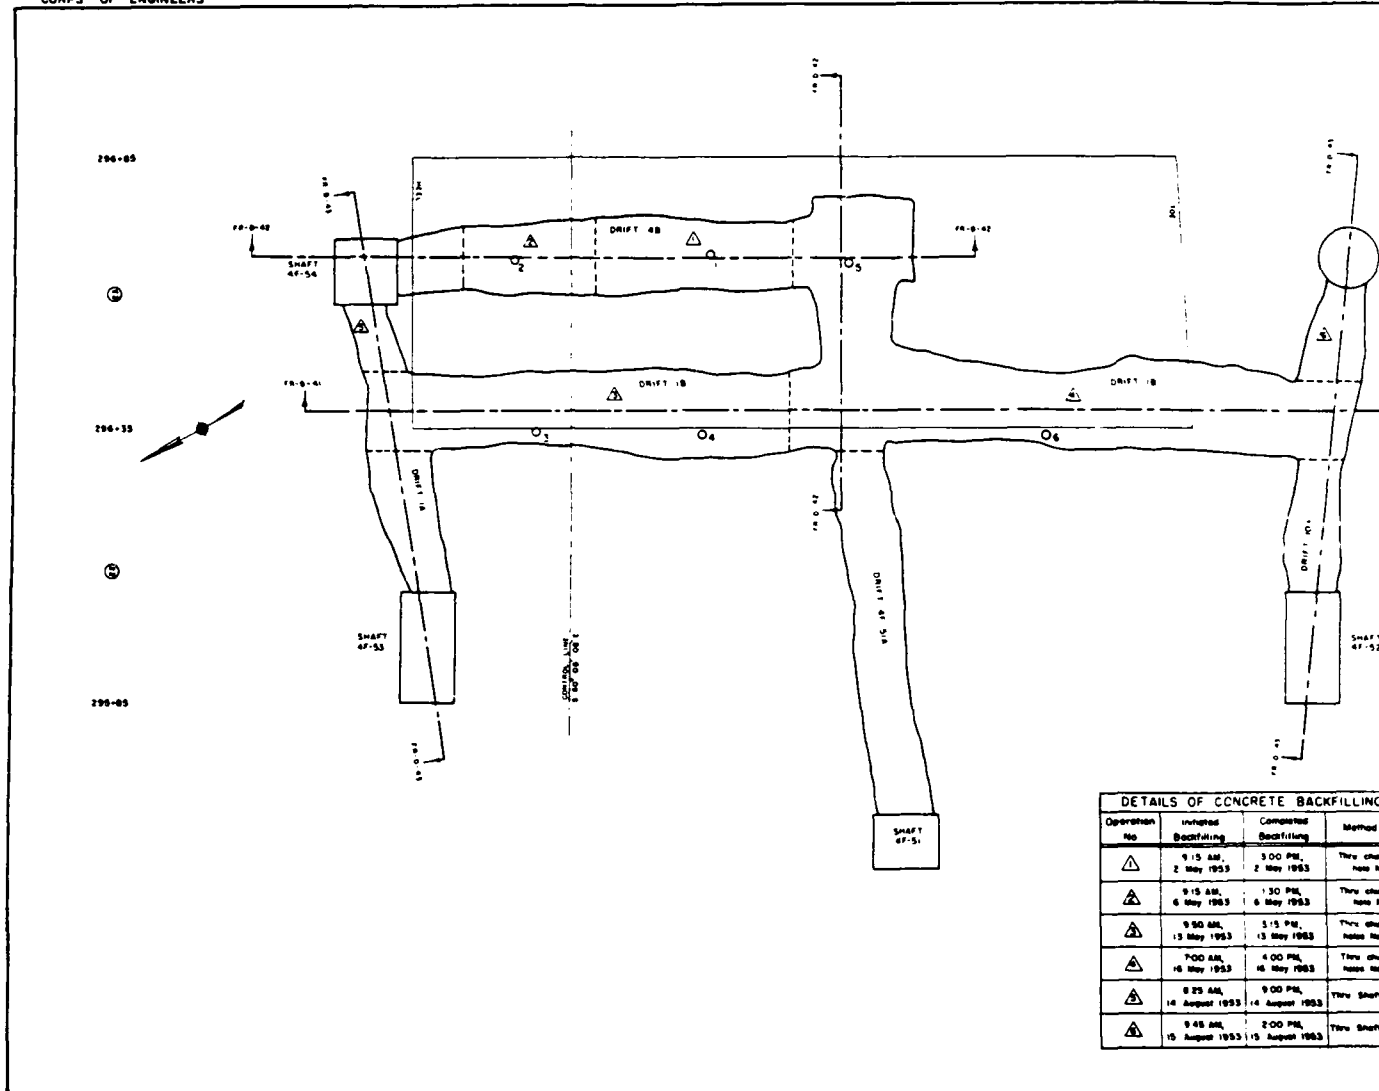
Figure 24. Layout of Mining Operations Concrete Gravity Dam Monolith

ning Operations Concrete Gravity Dam Monoliths 22-23.

62. Monolith 23 has a base length which ranges from 142 to 144 ft, and rises to heights of 199.5 to 211.5 ft above its foundation. The location of all drill holes and other pertinent features of this monolith are shown in Figure 25. A layout of the shafts associated with this area are shown in Figure 24. None of the pre-construction holes drilled in this area reached foundation material and subsequently will not be discussed. Several holes designated: 1F-123, 1F-147, 1F-171, 1F-204, 1F-206, 1F-217, and 1F-123 were

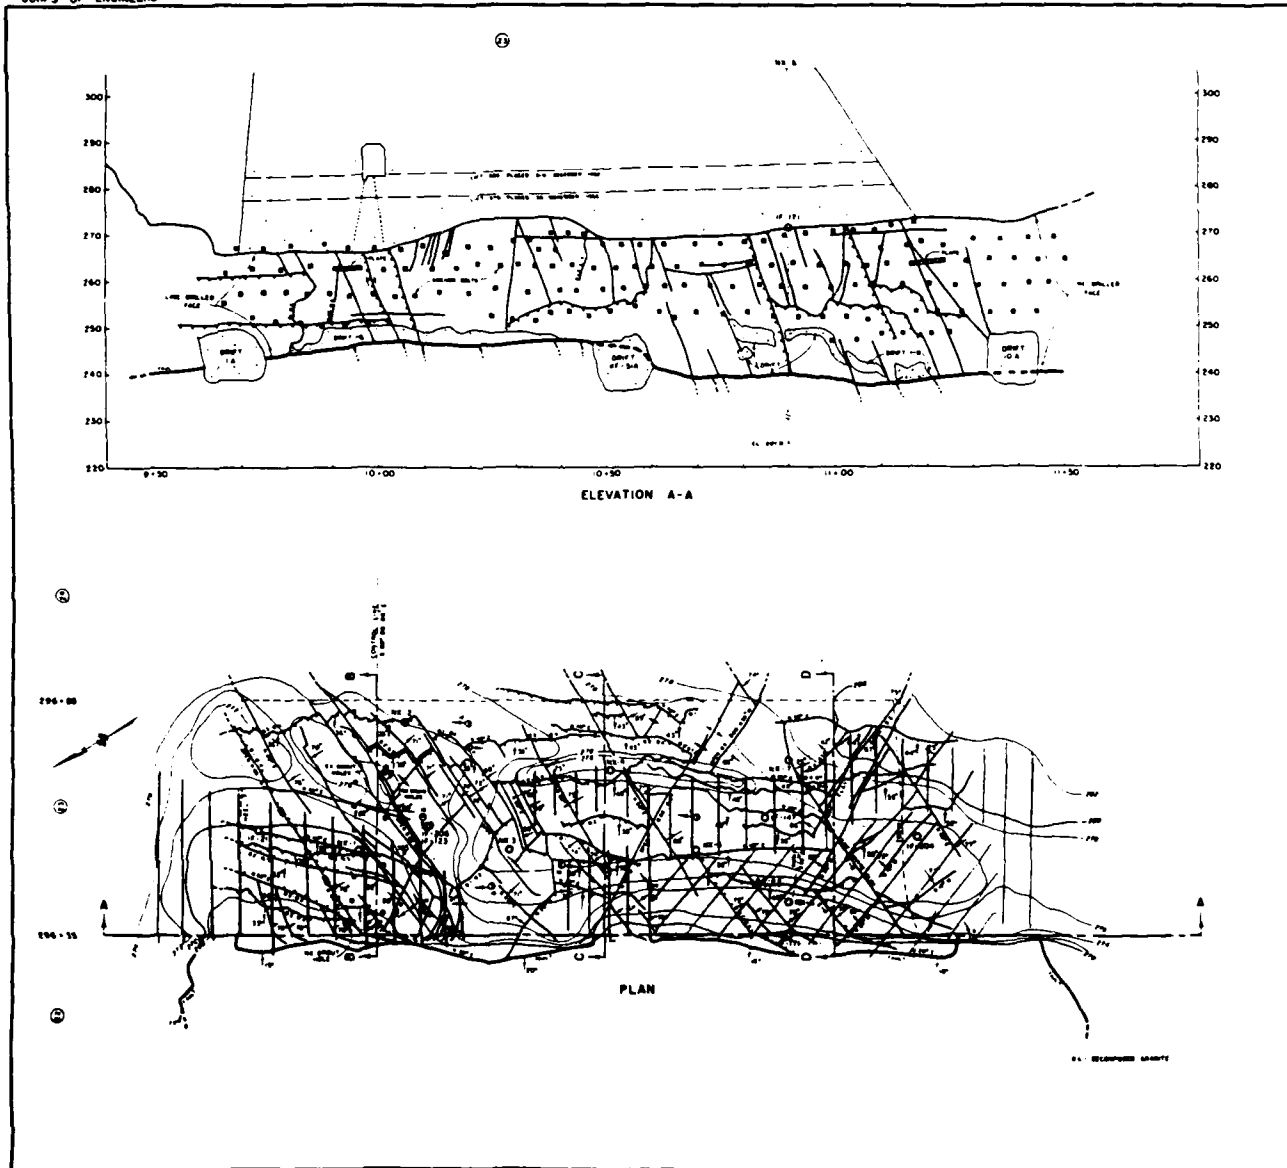
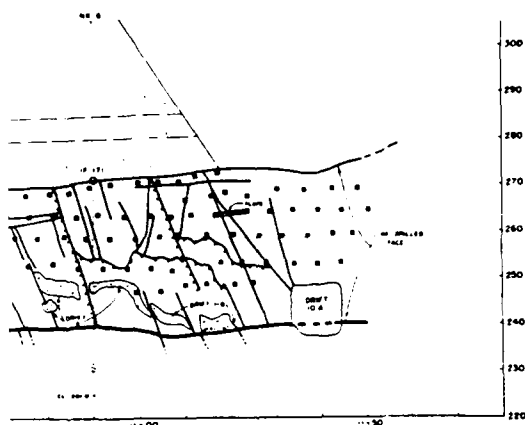
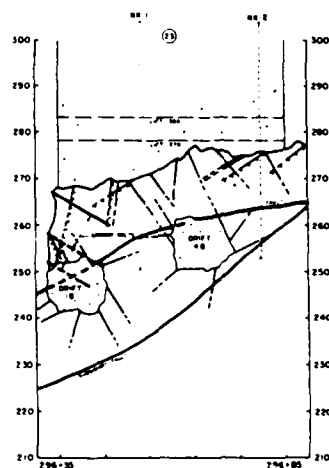
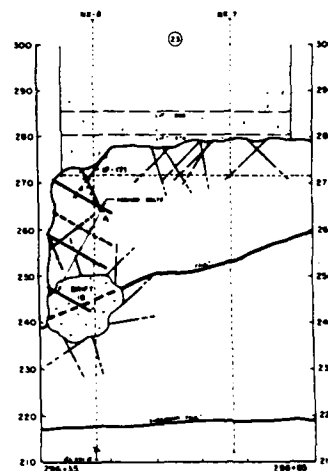
Figure 25. Plan and Sections of Concrete Gravity Dam Monoll

nd Sections of Concrete Gravity Dam Monolith 23.

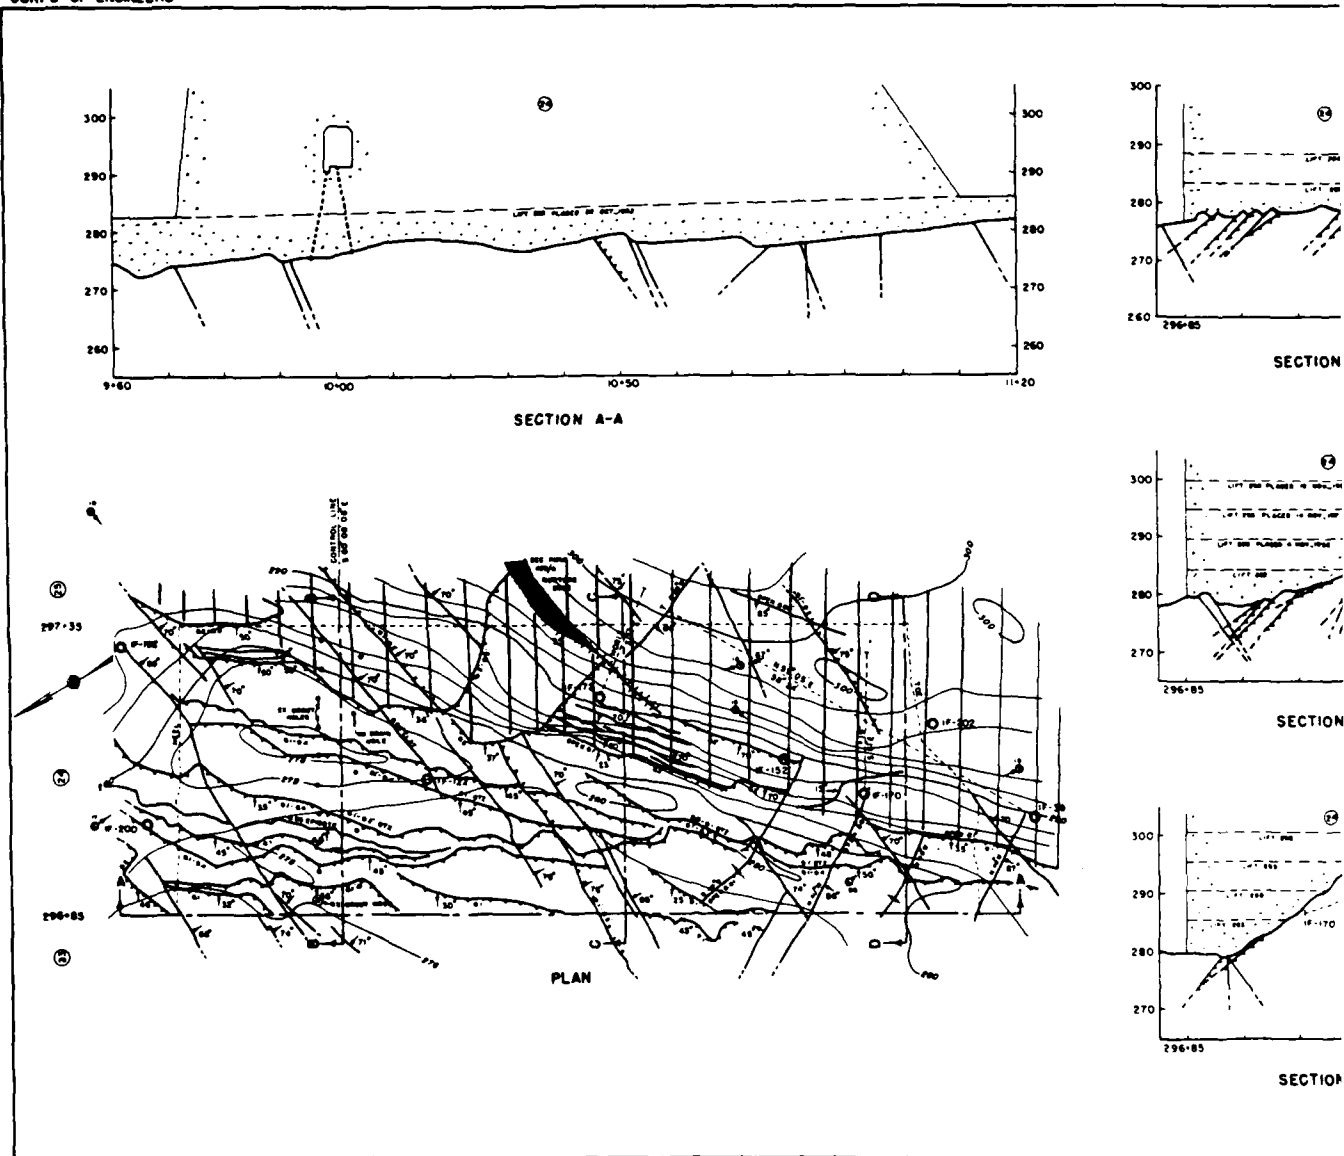
Figure 26. Plan and Sections of Concrete Gravity Dam Mono

Sections of Concrete Gravity Dam Monolith 24.

64. Monolith 24 is 143.5 ft long at the base and rises to a maximum height of 211.5 ft above its foundation. The location of all drill holes and other pertinent features of this area are shown in Figure 26. One hole designated 1F-39 (battered N 50° E at an angle of 58°) was placed into the foundation beneath this monolith, pre-construction. This hole was drilled from the toe of Monolith 23 at an angle such that it terminated at el 221.5 beneath Monolith 25. The hole first entered sound rock at el 296.8 where it continued to the bottom of the hole. Several holes were placed into the foundation post-construction. Hole 1F-22 was drilled from el 311.5 to el 209.1. Below el 285.0 the granite was sound and very little core loss occurred. Hole 1F-152 was drilled to bottom el 261.5, sound relatively unweathered granite occurred below el 294.0. Core hole 1F-172 was drilled horizontally toward Monolith 26 along el 289.2, all the rock explored was slightly weathered granite. Hole 1F-192 was drilled just upstream of the Monolith 25 heel and was for the purposes of locating the fault. The actual fracture which defines the fault could not be determined from the hole drilled to bottom el 236.7. Core hole 1F-200 was a secondary exploratory hole at the heel of Monolith 25.

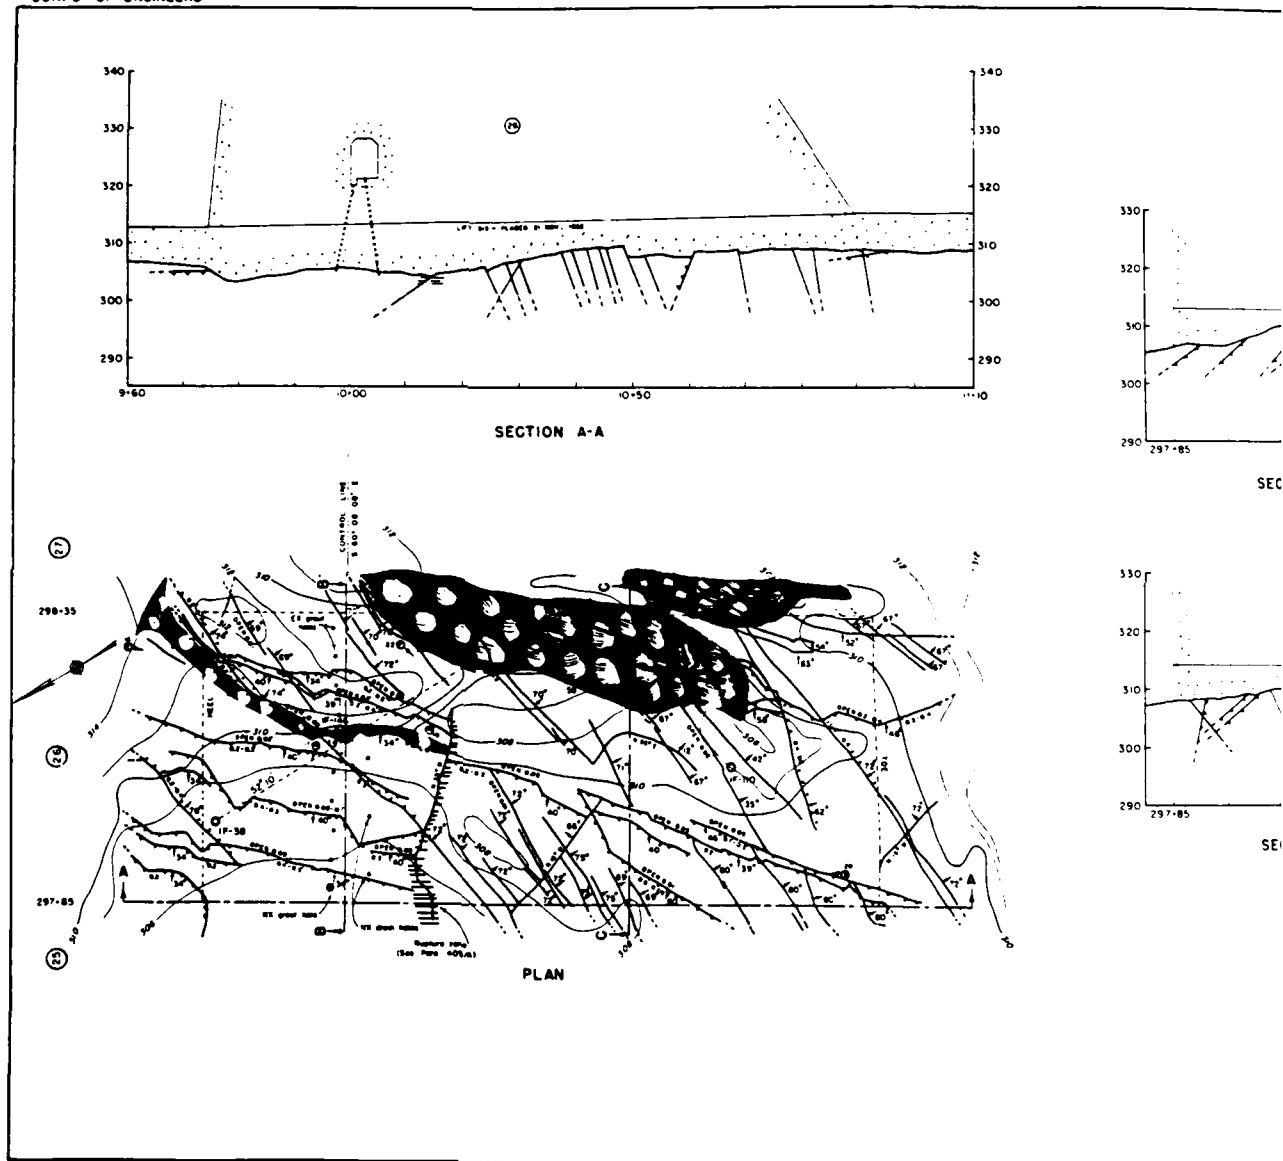
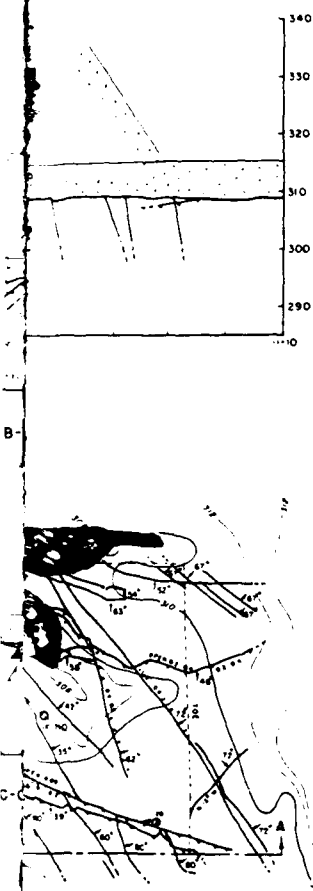
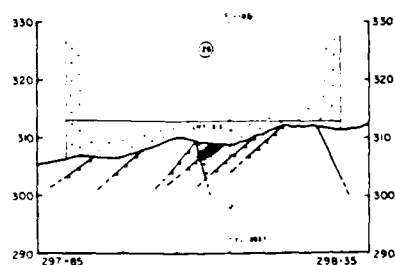
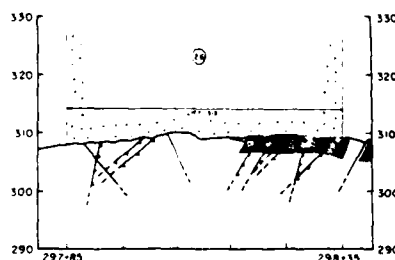
Figure 28. Plan and Sections of Concrete Gravity Dam Mond

2nd Sections of Concrete Gravity Dam Monolith 26.

68. Monolith 26 is 118.6 ft long at its base and rises 173 ft above its foundation. The location of all drill holes and other pertinent features of this area are shown in Figure 28. Pre-construction hole 1F-38 (battered 52° in a direction S 02° E) was drilled approximately 25 ft upstream from the heel of Monolith 26. Below el 299.9 the core represented zones of soft, weathered rock alternating between zones of sound granite weathered to lesser degrees. Two holes were placed into the foundation after some initial excavation had occurred. Hole 1F-110 encountered sound granite between elevations 325.2 and 289.1. Hole 1F-146 was drilled to a bottom elevation of 283.7 and revealed sound foundation rock below el 317.7.

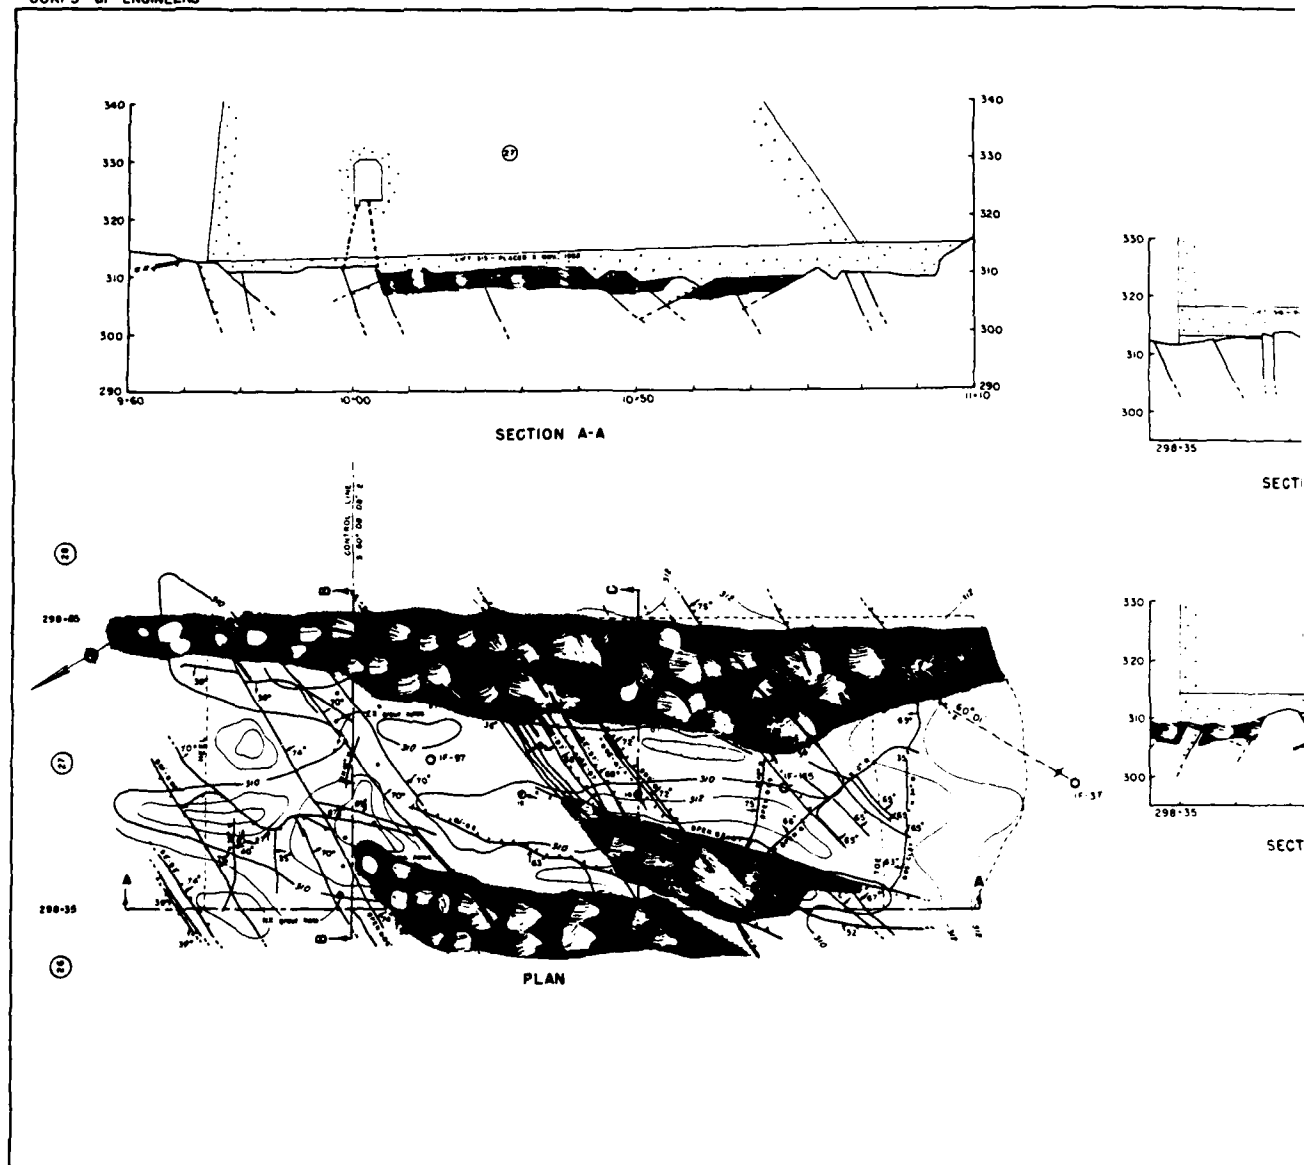
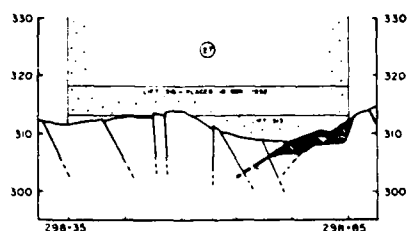
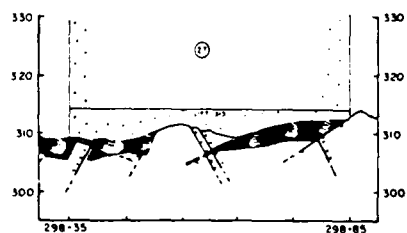
Figure 29. Plan and Sections of Concrete Gravity Dam Mo

and Sections of Concrete Gravity Dam Monolith 27.

70. Monolith 27 is 118.6 ft long at its base and rises approximately 173 ft above its foundation. The location of all drill holes and other pertinent features of this area are shown in Figure 29. Hole 1F-37 (battered 60° in a direction of N 60° E) was drilled into the foundation prior to any construction or excavation. The hole was bottomed at el 221.2, and entered sound granite at el 304.7. Two post-construction holes were placed into the Monolith 27 foundation. Hole 1F-97 drilled from el 321.0 to 216.6, encountered sound rock below el 318.1. Hole 1F-145 revealed that sound rock existed beneath el 323.4.

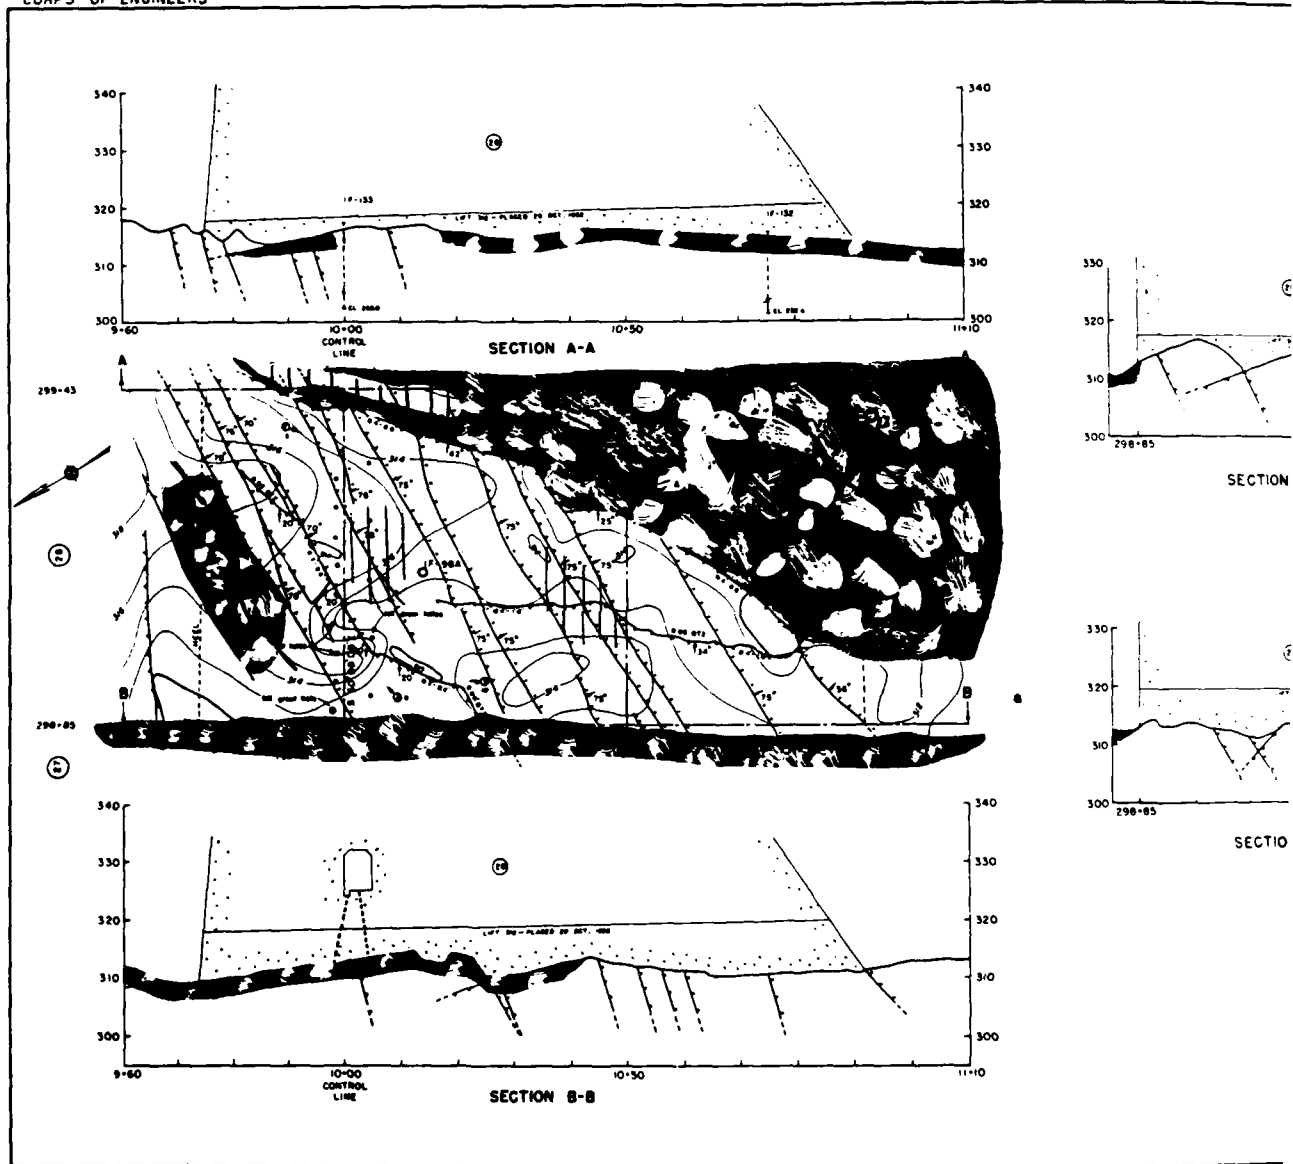
Figure 30. Plan and Sections of Concrete Gravity Dam Mon

FOLSOM PROJECT
 AMERICAN RIVER, CALIFORNIA
 FOUNDATION REPORT
 MAIN CONCRETE DAM
 MONOLITH 28—PLAN & SECTIONS

72. Monolith 28 is 111.2 ft long at its base and rises approximately 167 ft above its foundation. The location of all drill holes and other pertinent features of this area are shown in Figure 30. Four holes were placed into the foundation after some initial excavation had occurred. Hole 1F-98A was bottomed at el 214.5, and encountered sound rock at el 310.0. Hole 1F-108 was collared at el 319.6 and drilled to el 279.1. Core loss occurred as deeply as el 295.6, with this elevation being considered the top of sound rock. Hole 1F-132 reached to bottom el 232.4, where alternating zones of sound and intensely weathered granite were found to occur as low as el 244.4. Persistent areas of core loss, however, exist only as low as el 271. Hole 1F-133 was bottomed at el 258.0 and revealed the same characteristics as hole 1F-132.

73. Most prominent of the structural features beneath Monolith 28 were two joints tracing diagonally across the foundation; in addition another such joint was located heelward of the control line at the juncture of Monoliths 27 and 28. The joints contained broken quartz and were bounded by a soft zone of iron stained alteration. Practically all the rock to the southeast of the control line is intensely weathered granite. Here foundation rock occurs which is in the most advanced weathering stage of any rock beneath the Concrete Gravity Dam. Northwest of the intensely weathered area, the condition of weathering for the most part ranges from slight to moderate. Three small areas of relatively unweathered granite are shown Figure 30.

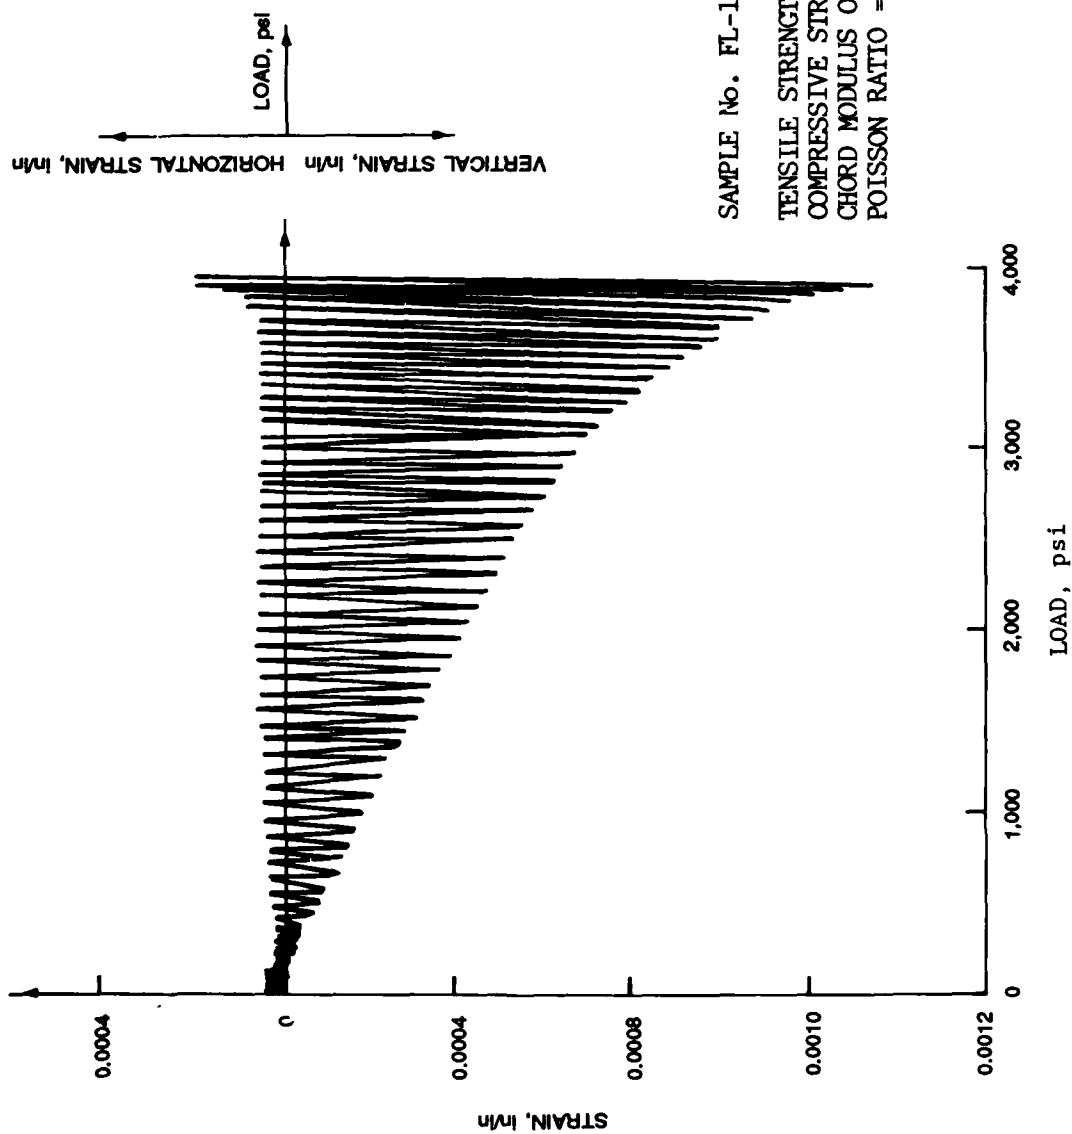
Figure C.1 Concrete Test Data for Sample No. FL-1

SAMPLE No. FL-1

TENSILE STRENGTH = NOT AVAILABLE
 COMPRESSIVE STRENGTH = 3784 psi
 CHORD MODULUS OF ELASTICITY = 2.365E + 06
 POISSON RATIO = 0.188

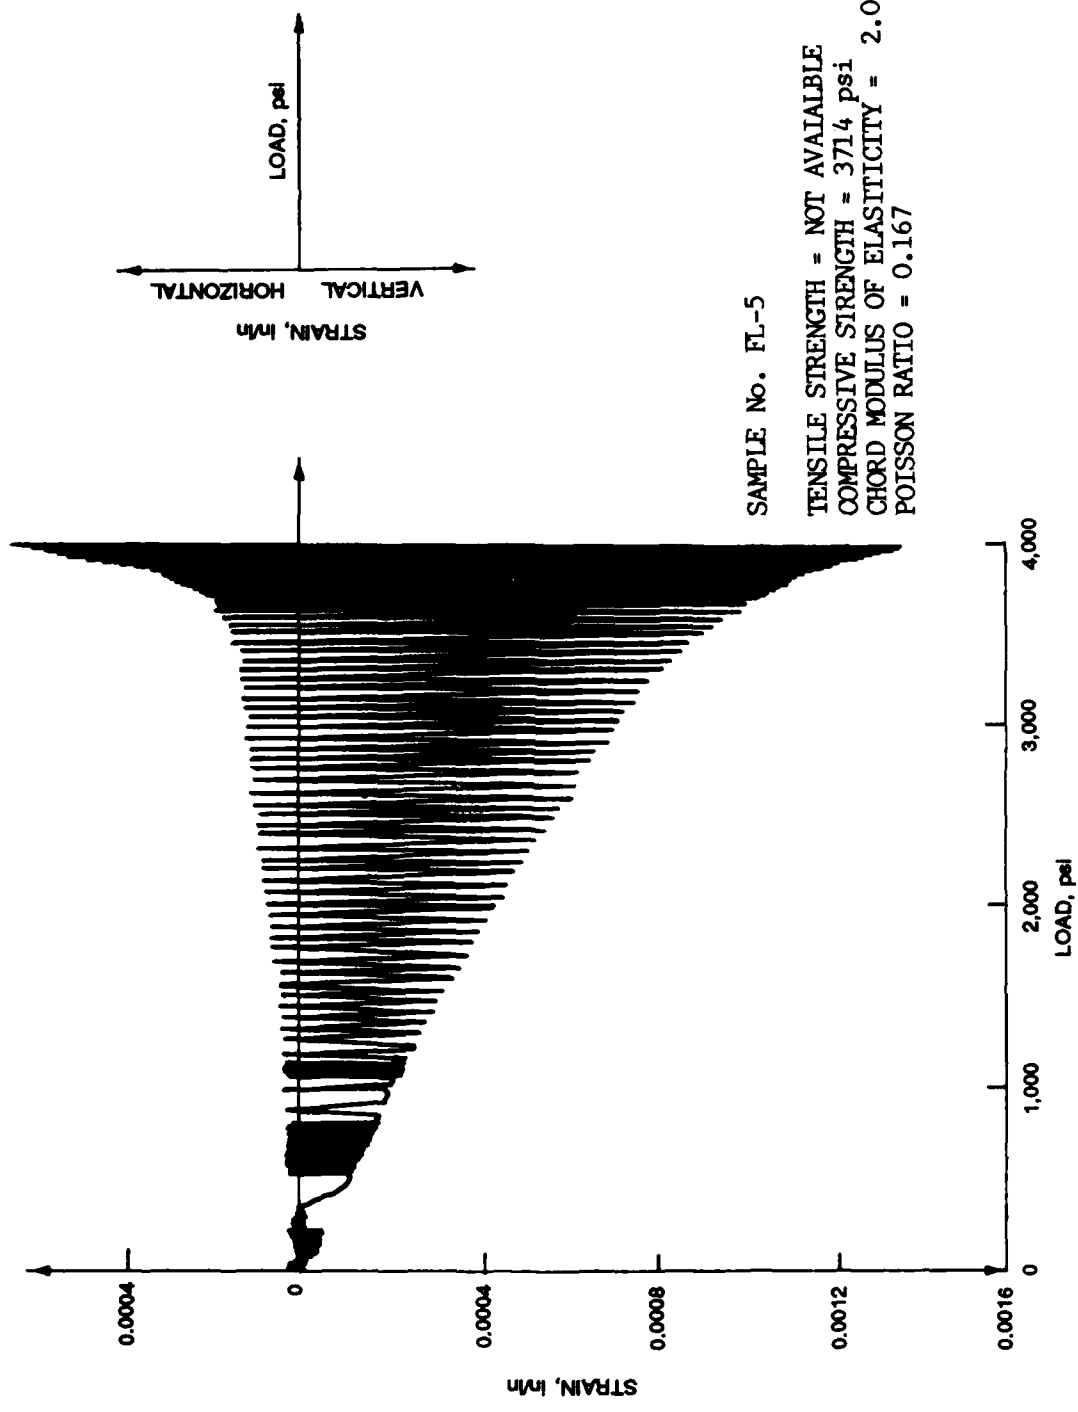
Figure C.2 Concrete Test Data for Sample No. FL-5

SAMPLE No. FL-5

TENSILE STRENGTH = NOT AVAILABLE
 COMPRESSIVE STRENGTH = 3714 psi
 CHORD MODULUS OF ELASTICITY = $2.063E + 06$
 POISSON RATIO = 0.167

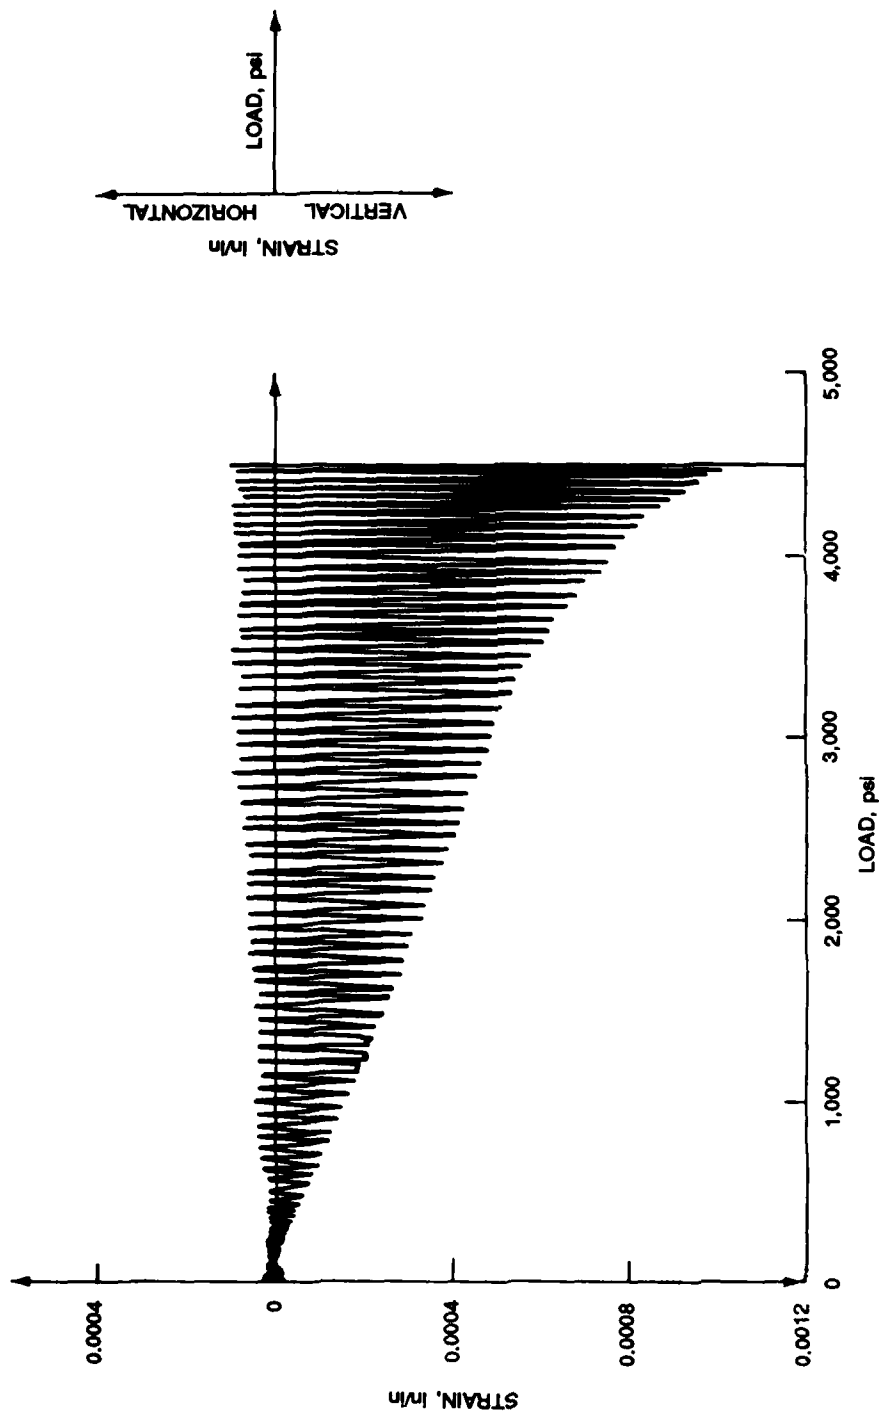
Figure C.3 Concrete Test Data for Sample No. FL-6

SAMPLE No. FL-6

TENSILE STRENGTH = NOT AVAILABLE

POISSON RATIO = 0.167

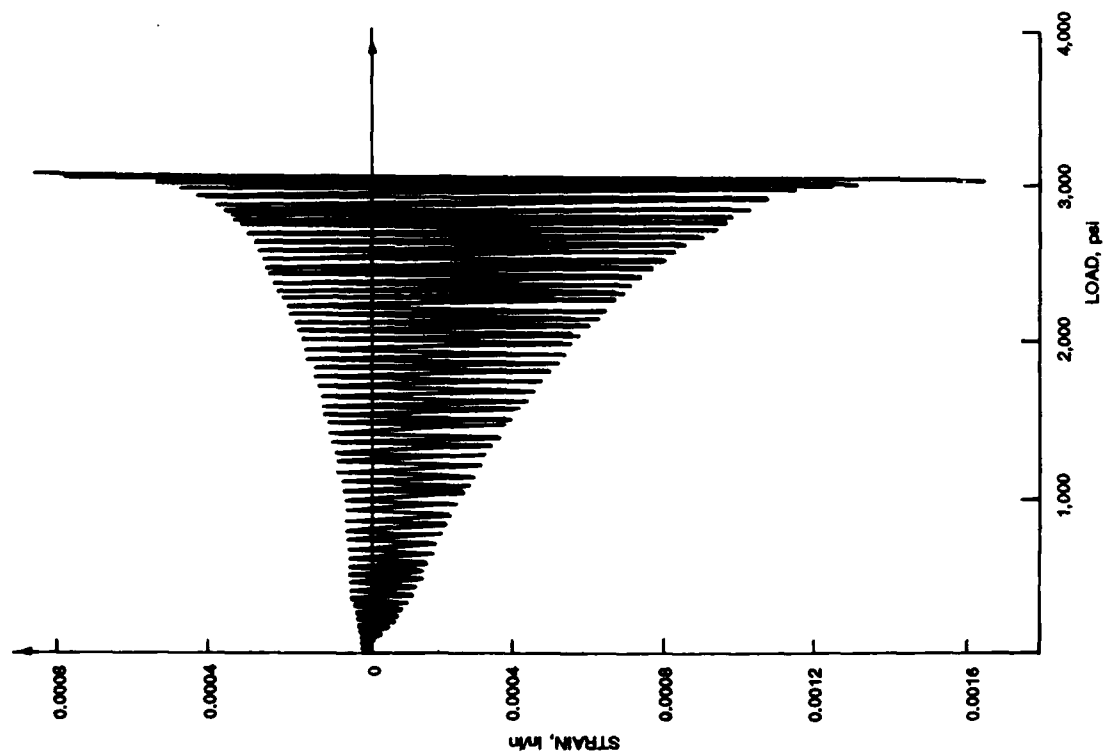
Figure C.5 Concrete Test Data for Sample No. FL-9

SAMPLE No. FL-9

TENSILE STRENGTH = NOT AVAILABLE
 COMPRESSIVE STRENGTH = 2829 psi
 CHORD MODULUS OF ELASTICITY = $1.664E + 06$
 POISSON RATIO = 0.294
